GOOD CATCH from **The American Club**

Pilot Ladder Safety Part 2: Retrieval lines

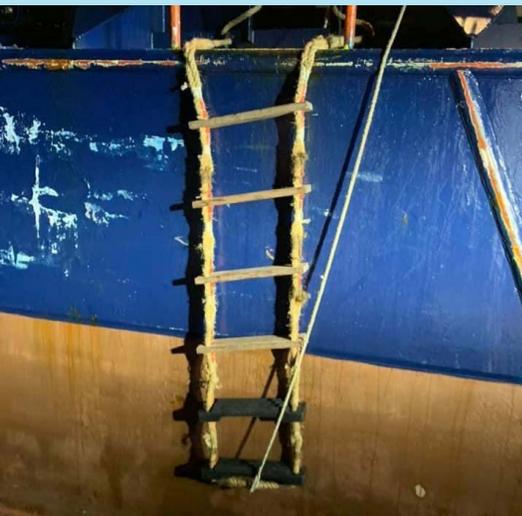
This ladder is not classified as a pilot ladder, since it has no spreaders and four rubber steps. The retrieval line is in the way of the steps.

International Maritime Organization Assembly Resolution A.1045(27), Recommendations on Pilot Transfer Arrangements, paragraph 2.1.5 recommends that when a retrieval line is considered necessary to ensure the safe rigging of a pilot ladder, the line should be fastened at or above the last spreader step and should lead forward. The retrieval line should not hinder the pilot nor obstruct the safe approach of the pilot boat.

The reason for this is very simple: A retrieval line suspended under the bottom spreader can easily get caught in the fenders or bollards of the pilot boat, or the pilot's leg can get entangled in it. Ensure the retrieval line is correctly rigged every time as the pilot's safety is dependent upon it.

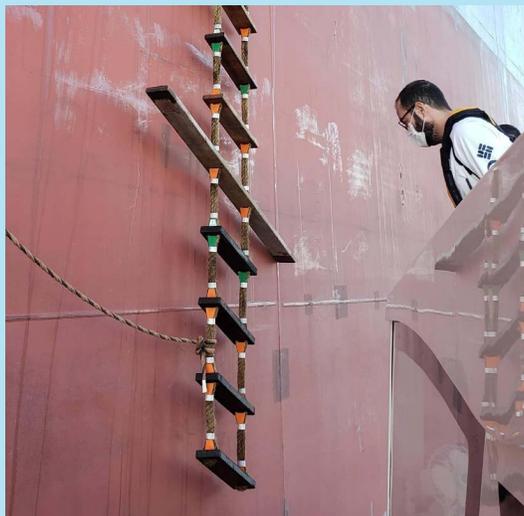
A pilot ladder in excellent condition, but the location of the retrieval line on this long pilot ladder does not seem fixed for ease of retrieval by the crew.

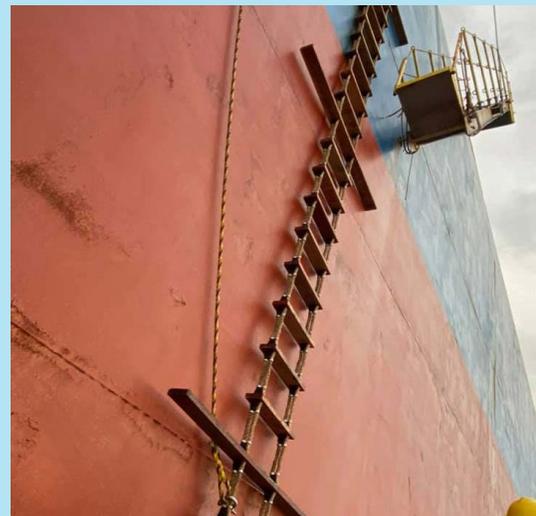
Although this retrieval line seems not be in a position that would increase risk of entanglement, it has been affixed at least two meters above where it should have been affixed.

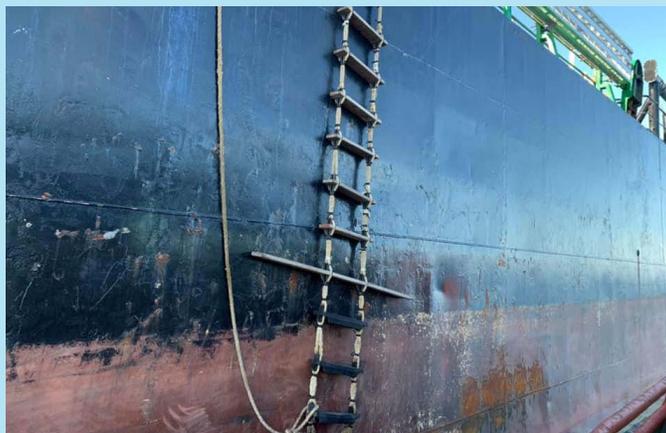
This slack retrieval line could be a source of trouble for a pilot in heavier seas.
